COMMENTS: **Part 21 Initial Notification and Preliminary Report - Cutler-Hammer A200 NEMA Size 1 Starters**

Equipment Identification: Starter, Non-Reversing, Size 1, 600VAC, 3 Pole, W/125VDC coil, Westinghouse/Cutler-Hammer P/N A200M1CS, Type B Thermal Overloads, Ambient Compensated, Manual Reset Only

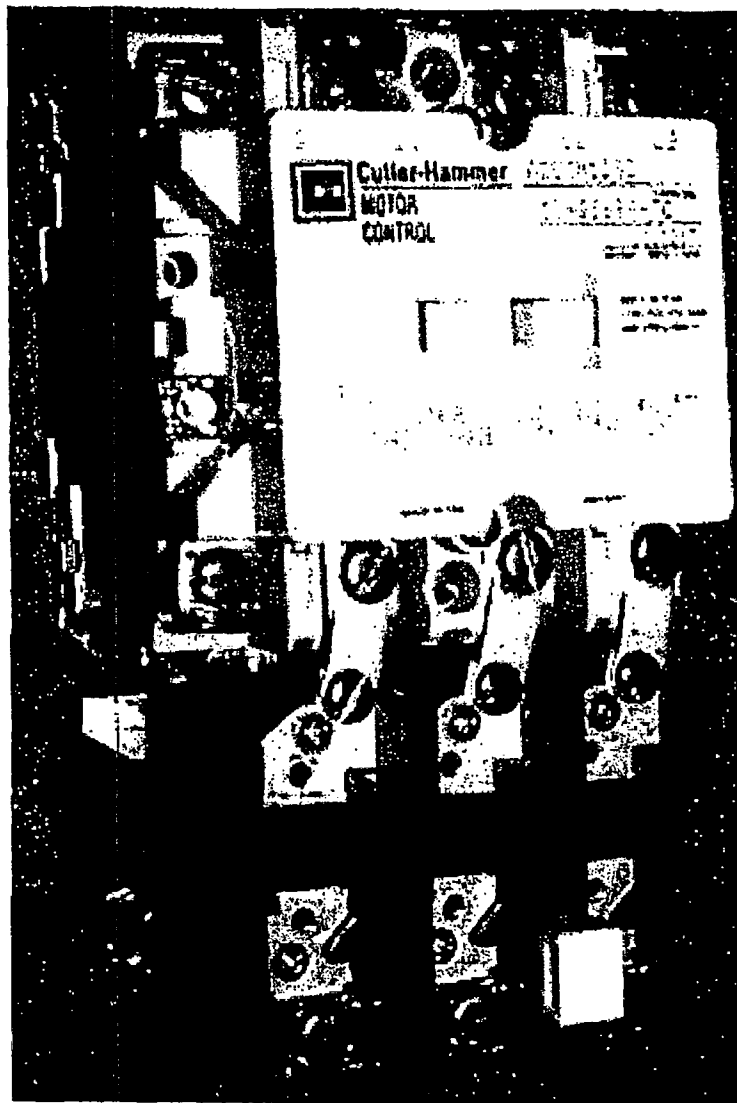
Figure 1. Contactor

Figure 1 (attached) shows the starter as received and the coil after removal from the starter. No other defects were seen in the starter assembly except for in the failed coil.

Cutler Hammer Motor Control

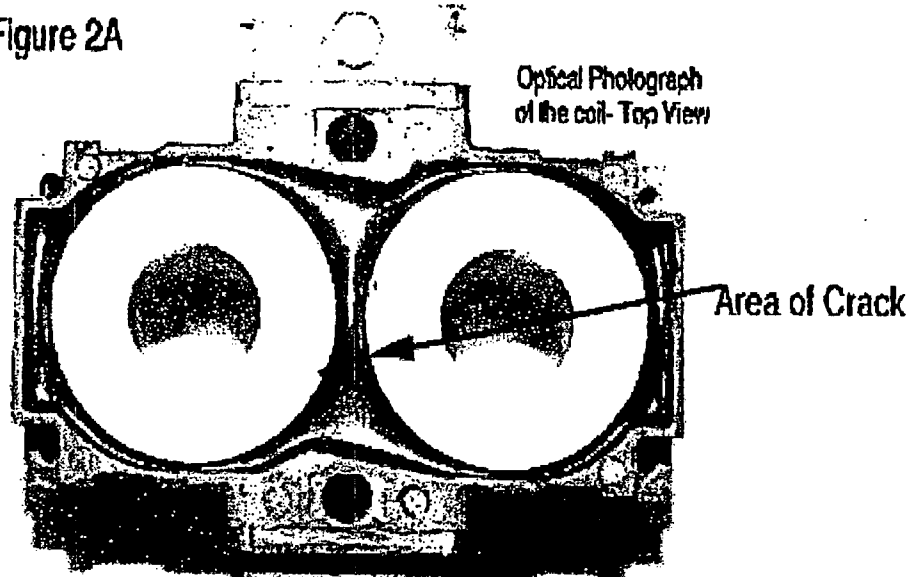
Figure 2A

Figure 2 (attached) shows: (A) an optical photograph of the coil before disassembly and sectioning, (B) a radiograph which identifies the crack location, and (C) an enlargement of the radiograph showing where the wire failed.

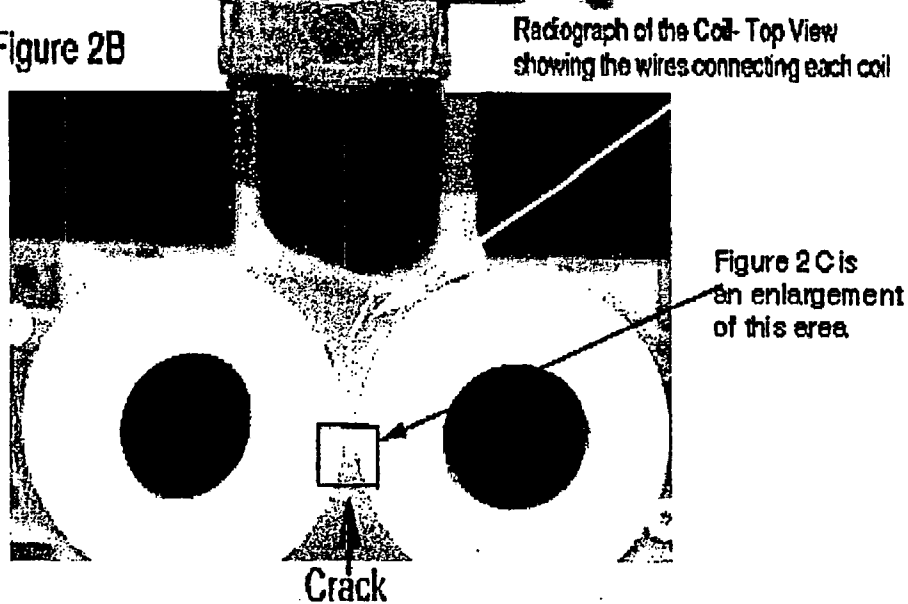
Figure 2B

It was determined that the failure is the result of a manufacturing defect in the epoxy surrounding the coil. The open circuit was caused when the epoxy cracked at the defect and broke a wire running through the epoxy. This wire connected the two coils and this failure caused the open circuit. The defect in the epoxy was caused by the tape surrounding the coils. A piece of the tape protruded into the area between the coils where the epoxy is poured. This created a weak area which resulted in the failure during service.

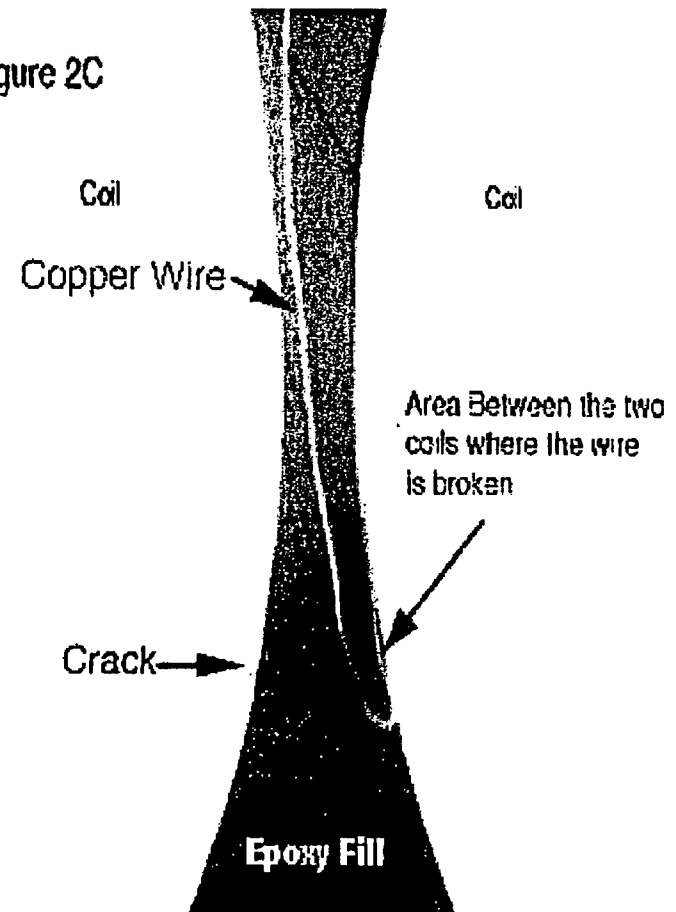
Figure 2C

Enlargement of Figure 2B
Area between the two coils

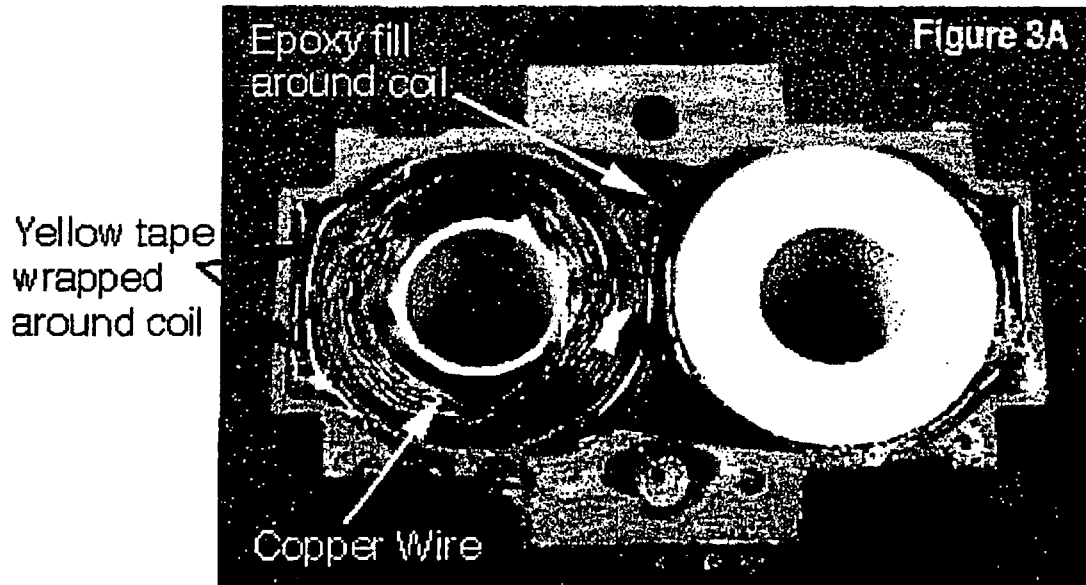
Figure 3 (attached) shows: (A) an optical photograph of the coil with one plastic cover removed. (B) the coil cross section. The coil was constructed by inserting the copper wire (wrapped in yellow tape) into the housing. Epoxy was then poured into the housing and hardened in stages. (C) shows the epoxy surface with the crack. Some of the copper wire and yellow tape has been removed to show the crack.. Figure 3C shows the epoxy surface with the crack.

Top view of coil with plastic cover removed

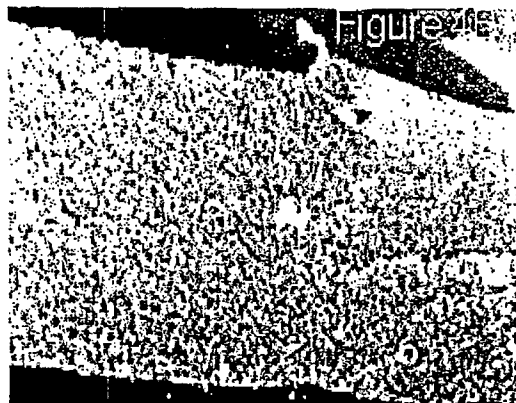
The epoxy also separates the two coils except for the copper wire running between them. The yellow areas seen in Figures 4A and 4C are where the yellow tape is sticking out into the epoxy. Figure 4A shows the cracked epoxy surface. The yellow area on the surface is where the tape protrudes into the epoxy. Figure 4B shows the surface of the fracture where the copper wire broke. Figure 4C is a scanning electron microscope photograph of the fracture surface showing the yellow tape. This is the area where the fracture originated. Figure 4D shows an optical photograph of the fracture origin. The fracture surface appears brittle and lines radiating away from the origin can be seen.

No signs of overheating, tackiness or discoloration are visible.

Fracture Surface with broken wire

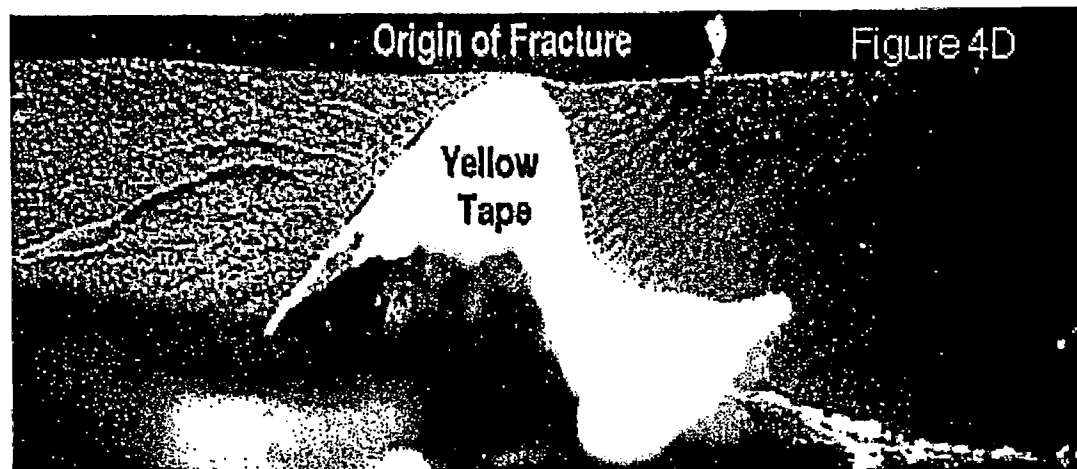
Fracture surface where the incursion of tape caused a weak area in the epoxy
